# LIMITED SCOPE EVALUATION OF BUILDING EXTERIOR - FINAL

**Herschler Building**

125 W. 25<sup>th</sup> Street

Terracon Project No. F6149127

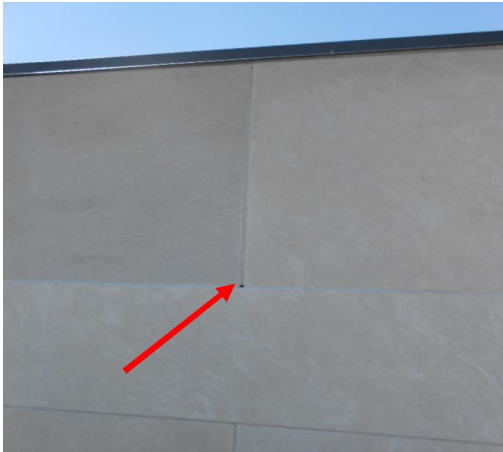
**Photo #1** Exterior weep holes at the base of the parapet wall (typical).

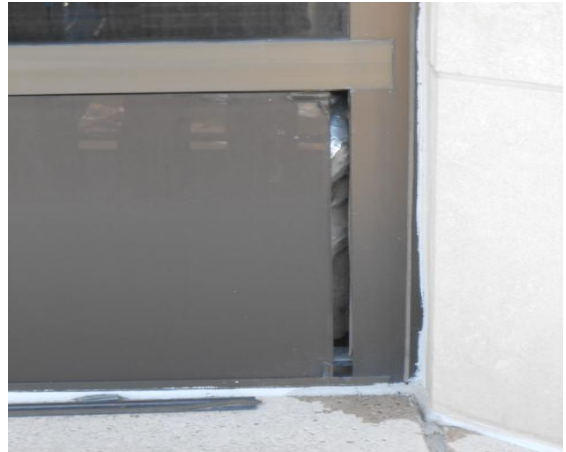
**Photo #2** Typical separation of window from frame multiple observed at multiple locations.

Window replacement is recommended, the selection of which may be based on cost. However, Terracon recommends windows by the following manufacturers be considered for the replacement option:

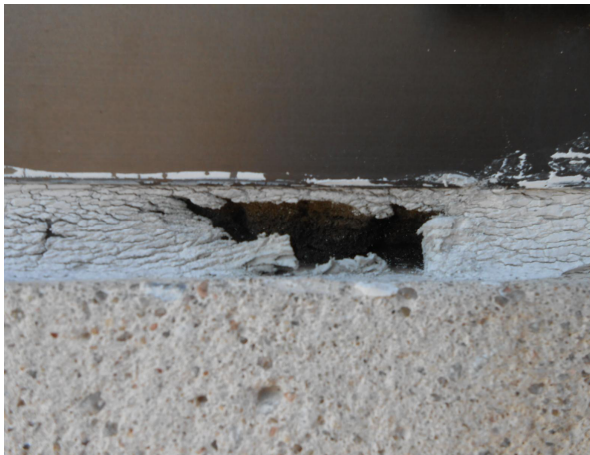
**Photo #3** Typical condition of the exterior joint sealants. (Approx. 1.25 in. X 0.375 in.)

require grinding. Terracon recommends installing new sealants with silicone, as this sealant material has approximately a 20-year life expectancy compared to urethane, which has approximately a 7-year life expectancy. The grinding may be necessary because silicone will not adhere to a urethane base.

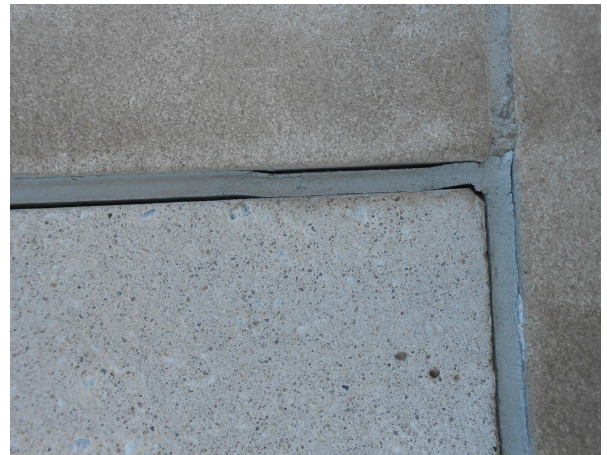
**Photo #4** Typical condition of the exterior joint sealants.

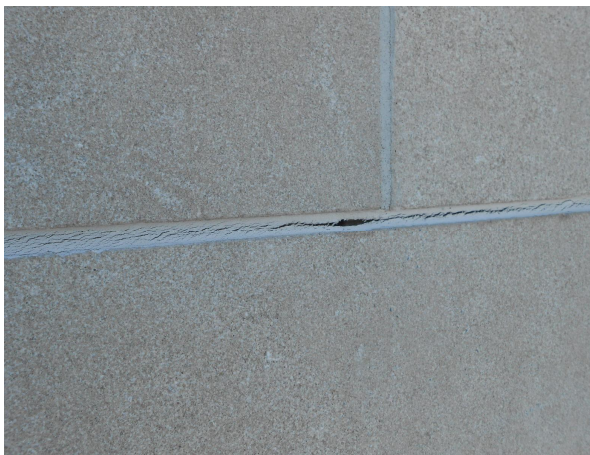
**Photo #5** Typical condition of the exterior joint sealants.

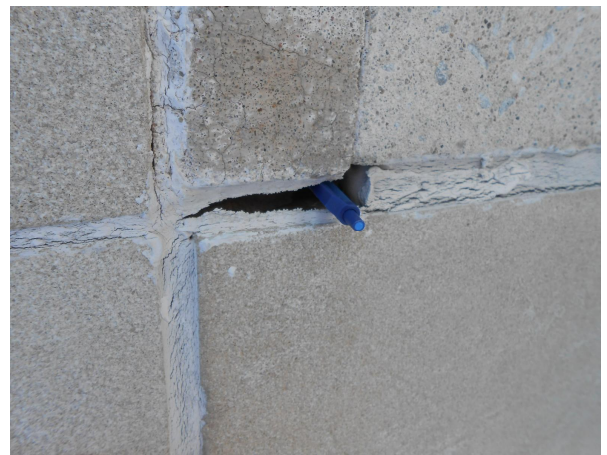
**Photo #6** Typical condition of the exterior joint sealants. (Approx. 0.375 in. X 1.5 in.)

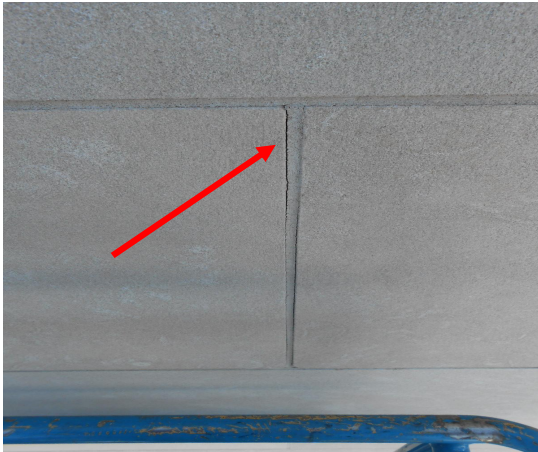
- 17) The limestone panels have either sealant or mortar between them. Approximately 10% of the sealant and mortar joints are cracked or deteriorated to the point that a credit card could be inserted through them.

**Photo #7** Representative cracking (approx. 0.125 in. X 4 in.) in the mortar joints of the limestone panels.

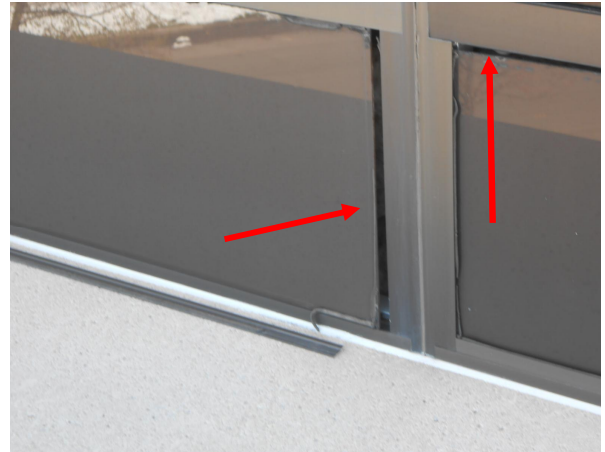
- 20) Several window gaskets around the perimeter of the building had failed, and the glass had become loose, which was likely the result of long-term exposure to ultra-violet radiation from sunlight. The windows did not appear to be thermally broken (i.e. no gaskets, wood

**Photo #8** Large gaps created by weathering of the window gaskets, typical at multiple locations.

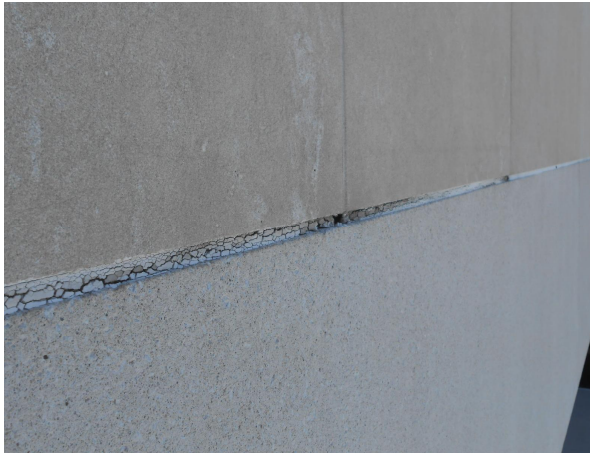
**Photo #9** Typical condition of the exterior joint sealants.

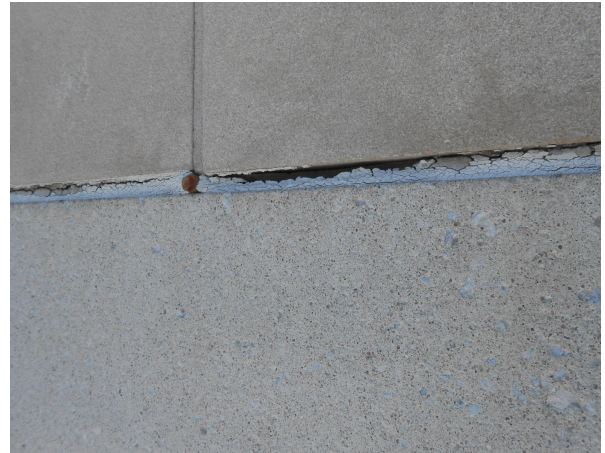
**Photo #10** Typical condition of the exterior joint sealants.

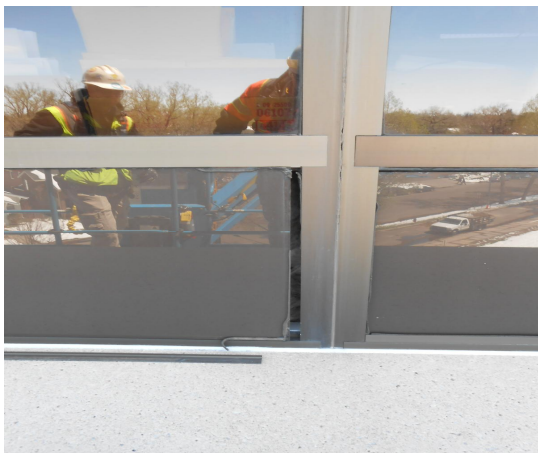
**Photo #11** Large gaps created by weathering of the window gaskets, typical at multiple locations.

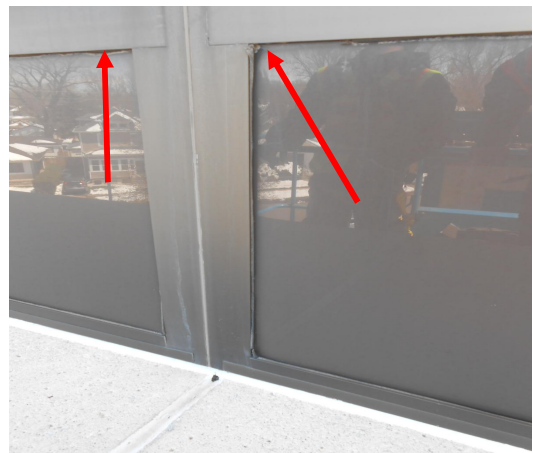
**Photo #12** Weathered confining gasket in the window panes of the curtain wall system.

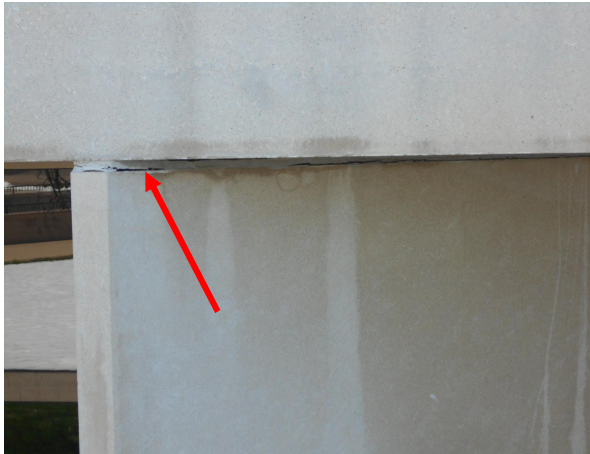
- 16) The precast concrete panels have joint sealant in between them. The sealant was observed to be highly weathered, deteriorated, and missing in many areas. The sealant was thought to be urethane-based, not silicone-based, when photos were subsequently reviewed by Terracon engineers. Further discussion on sealants can be found in the Recommendations section of this Report.

**Photo #13** Typical weathered sealant joints between the precast fins on the south side.

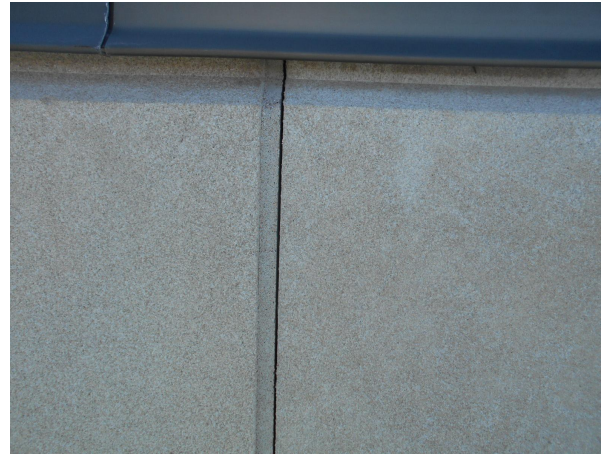
**Photo #14** Representative cracking in the mortar joints of the limestone panels.

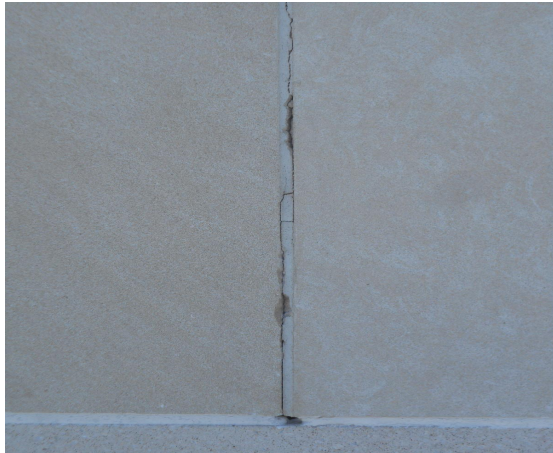
**Photo #15** Typical condition of the exterior joint sealants.

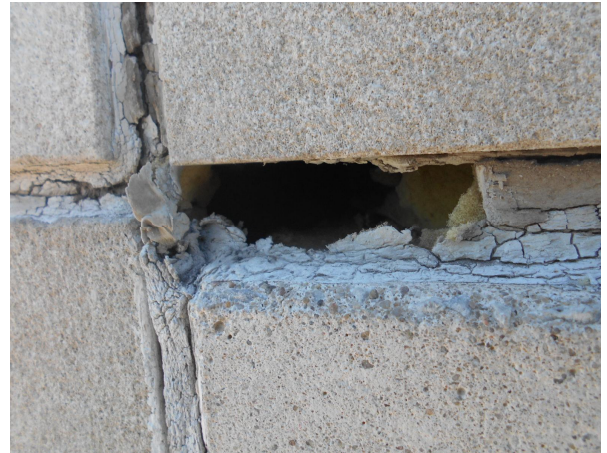
**Photo #16** Typical condition of the exterior joint sealants. (Approx. 0.625 in. X 1.5 in.)

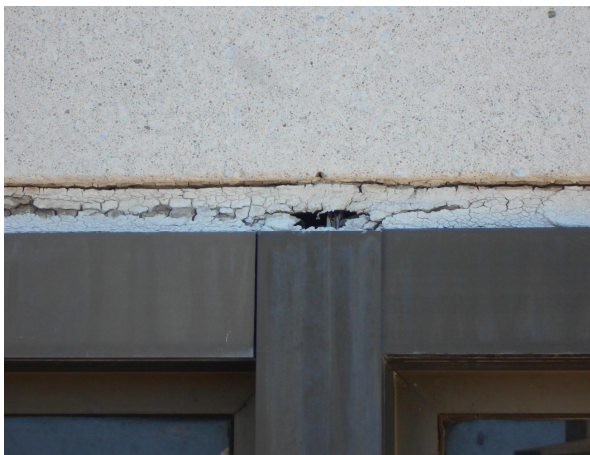
**Photo #17** Typical condition of the exterior joint sealants.

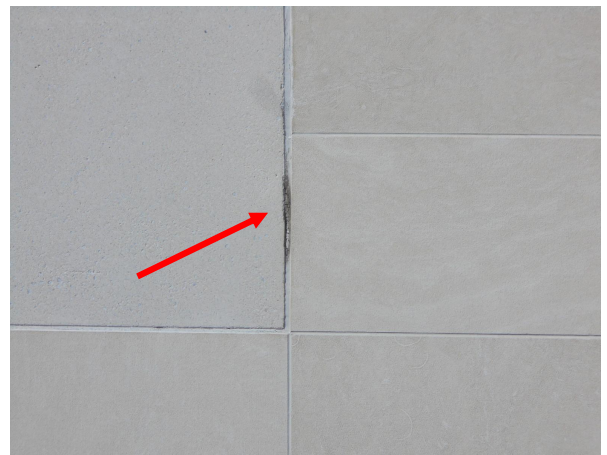
**Photo #18** Representative area where water penetrates through a weathered sealant joint.

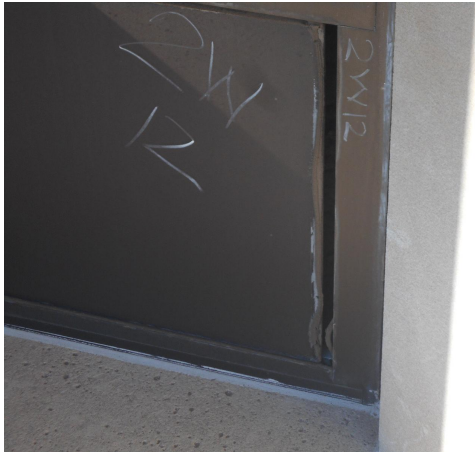
**Photo #19** Large gaps were observed at the sides of multiple windows.

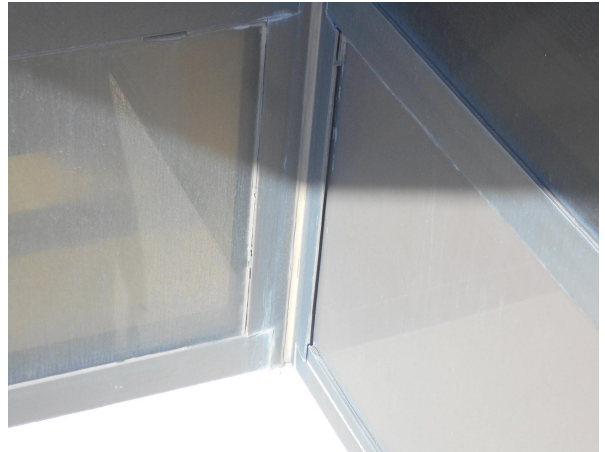
**Photo #20** Representative area of loose mullions in the curtain wall system.

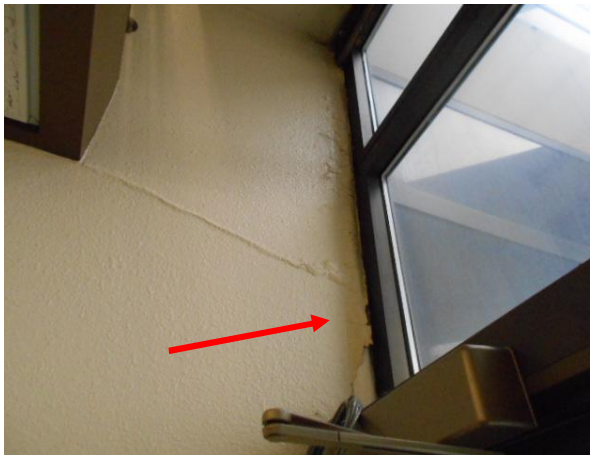
**Photo #21** Interior area where the paint is delaminating. Same area as seen in photo #20, but on the inside.

Localized areas of delaminating vinyl wallpaper, paint, and drywall on the interior of the cladding, should be repaired as necessary. As the exterior of the building at these locations gets repaired, water intrusion issues should cease. Stained ceiling tiles should be replaced after other repairs have taken place.

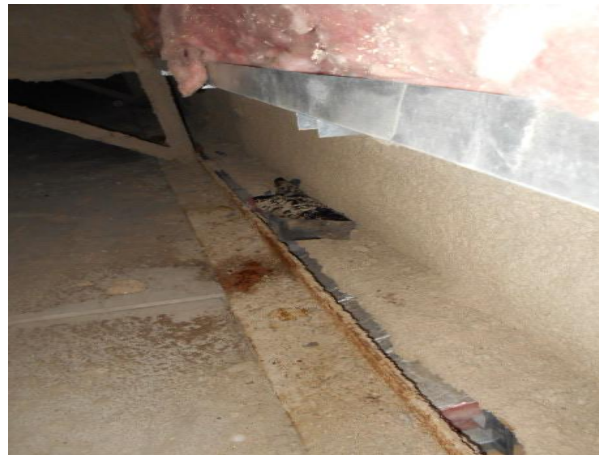
- 15) Steel kickers brace the precast concrete and limestone panels to the main steel frame of the building. It appears that nearly all of the kickers have visible surface rust, although the Terracon structural engineer noted that the steel kicker shape and function did not appear to be compromised. It is likely that the kickers were installed without a rust-proof paint system. The main steel frame is painted and sprayed with fireproofing and did not show signs of rust. Some concerns were raised about the fireproofing of the steel, which had spalled in some locations. The severity of the spalling is of such a small distribution in the building, so as to be considered insignificant.

**Photo #22** Representative view of inside the precast soffit. Typical surface rust on the steel bracing.

Although the level of intensity of rust is unknown, Terracon recommends removing the rust by means of sand blasting and then following up with an application of rust protective paint or applied coating.

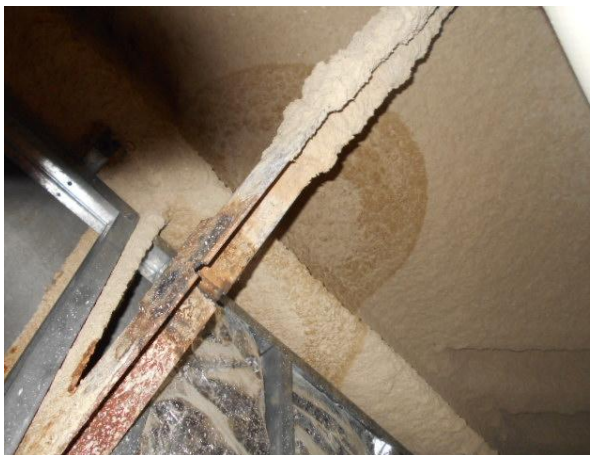
Terracon's structural engineer did not feel that the missing fireproofing constituted any appreciable risk, particularly because it is present in areas where cladding kickers are not fireproofed. This construction technique is not uncommon in buildings of this age and as such, would not be

**Photo #23** Representative view of inside the precast soffit. Typical surface rust on the steel bracing. Note the stain on the fireproofing.

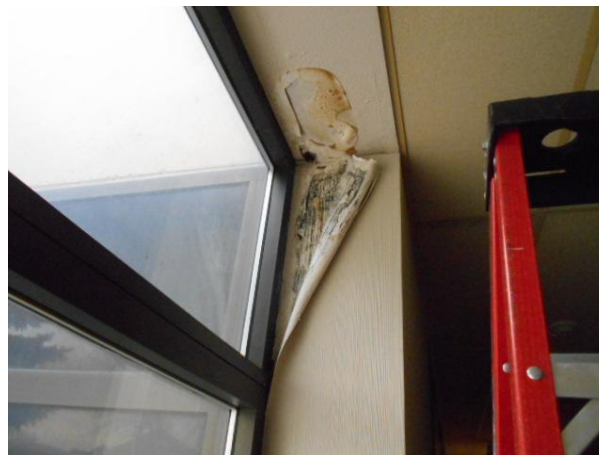
**Photo #24** Evidence of interior water intrusion.

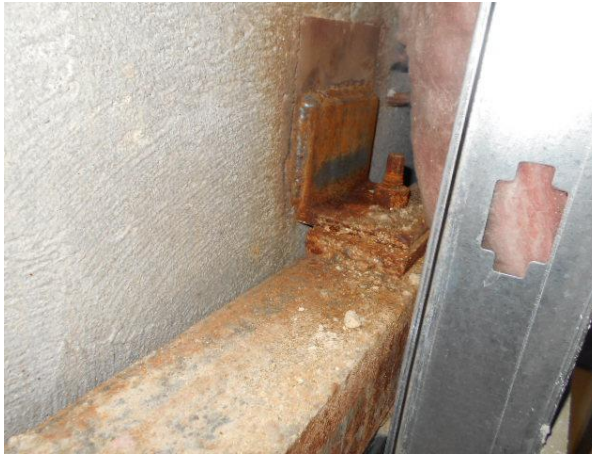
The condition of the precast and limestone panel interior support system indicates the presence of moisture due to the high amount of surface rust present. As demonstrated in the dew point calculations of the various building assemblies, water vapor is condensing within the building and forming on the interior building components. The support system was installed without any protection against rust and is therefore slowly deteriorating. Furthermore, due to the age of the building, and the apparent lack of maintenance, the conditions for condensation have significantly increased.

**Photo #25** Representative view above the drop-ceiling, where the exterior precast panels tie into the steel bracing; typical surface rusting.

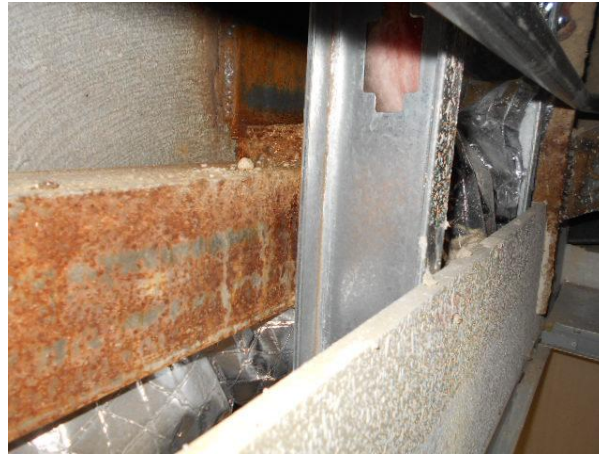
**Photo #26** Representative view above the drop-ceiling, where the exterior precast panels tie into the steel bracing; typical surface rusting.

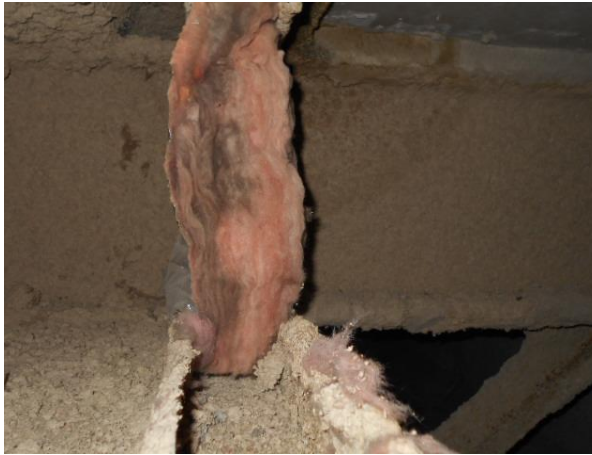
- 13) Open void spaces and a 4-inch layer of fiberglass insulation separate the precast “C” sections from the inside of the building. The fiberglass insulation was observed to have had striations of discoloration, a possible indication of mold, in some locations. No laboratory testing was performed to determine the presence/absence of mold or mildew. The mitigation of the problem is the preferred action. Testing for specific mold type is unnecessary so long as proper PPE is used in correcting the condition.

The dark striations observed on the fiberglass insulation inside the wall cavities and open ceiling areas could result from a variety of issues, including mold. Studies 4 and 9, Cases 1 and 3 and Study 6, Case 1 of the dew point calculations illustrate that the potential exists for water to condense within the wall. It cannot be shown conclusively that condensation or mold produced the striations. The area where the fiberglass insulation was observed is well ventilated with sufficient air flow and the insulation sample was dry to the touch.

**Photo #27** Fiberglass insulation separating the precast soffit area and drop-ceiling area with 4-inch max thickness.

Although the observed discoloration in the fiberglass insulation does not visually suggest the growth of mildew or mold, a more extensive investigation, such as field and laboratory testing, is recommended to further our understanding and safety of the employees and the building.

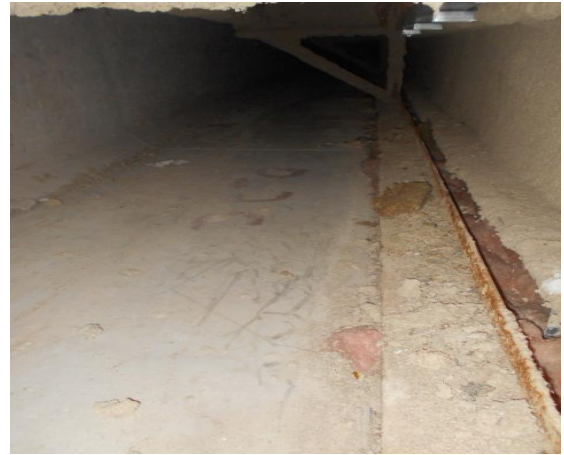
**Photo #28** Representative view of inside the precast soffits. Typical surface rust is visible on steel bracing.

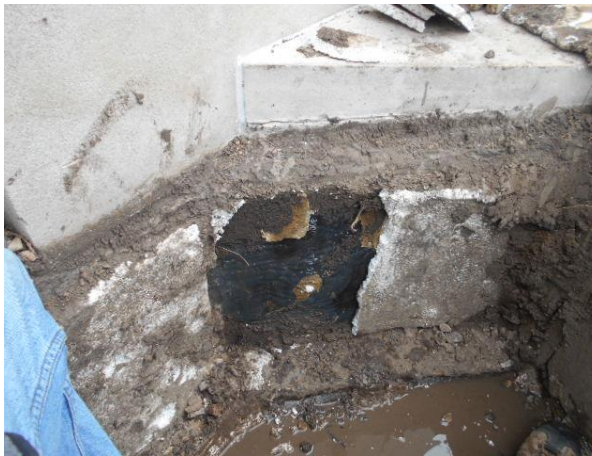
**Photo #29** Exposed waterproofing liner in the planter over the underground parking structure.

Plans include the removal of existing planters, but they are to be replaced with a different system. However, it is recommended not to place new planters above the underground parking structure.

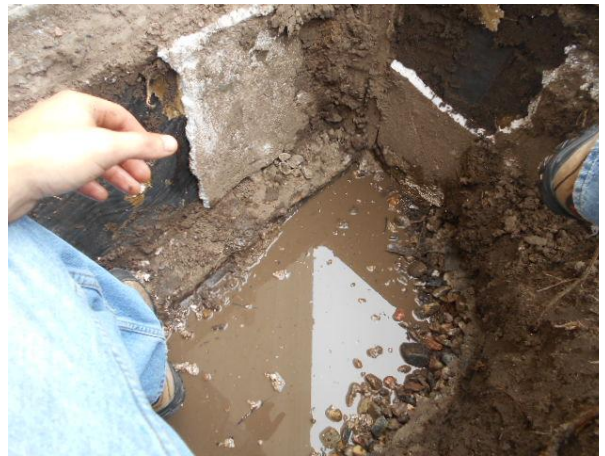
- 26) It is believed that a waterproof membrane/sheet is concealed beneath the concrete topping slab. The thickness of the concrete and any other components underlying the concrete are considered hidden conditions. The planters are to be removed as part of a building addition project; therefore, coring through the topping slab to obtain a cross section was deemed unnecessary.

**Photo #30** Exposed waterproof liner in the planter. Concrete covers the planter bottom. The presence of waterproofing beneath the concrete is unknown.

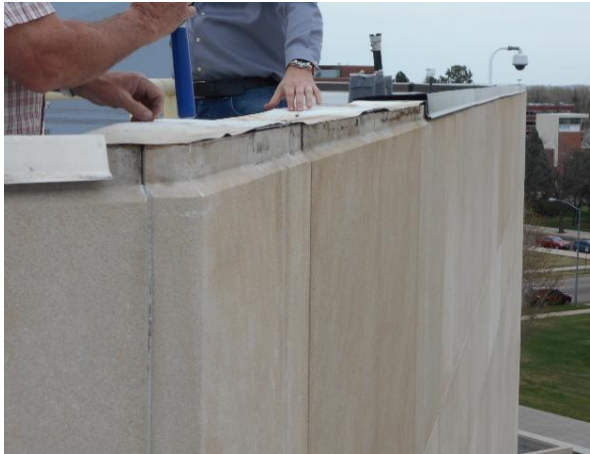
**Photo #31** Roof membrane termination at the top of the parapet wall.

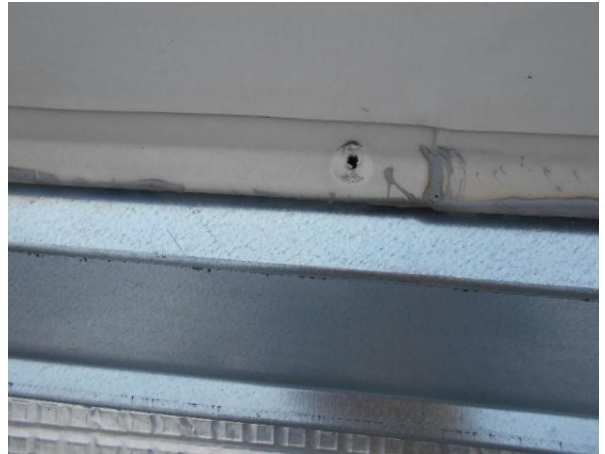
**Photo #32** One of many open screw holes in the roof membrane/counter flashing interface.

The roof appeared to be in generally good condition with the exception of several missing screws in the perimeter flashing and parapet flashing, which could allow moisture infiltration. These open holes should be filled with new screws, or sealed with a ultra-violet resistant sealant. The existing coping is generally in acceptable condition, although some spot replacement may be needed where new screws will not re-adhere the coping.

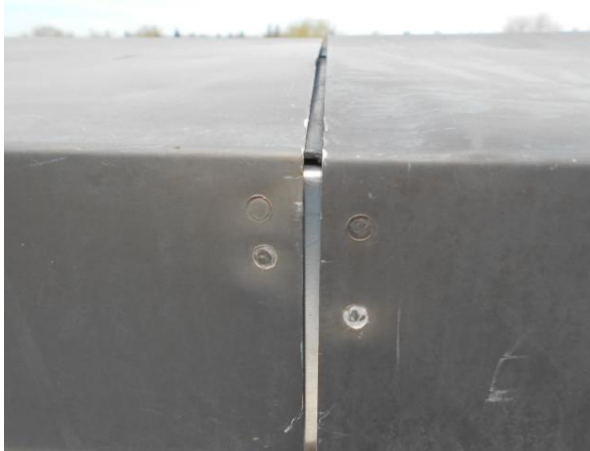
**Photo #33** Opening in the parapet wall coping cap.

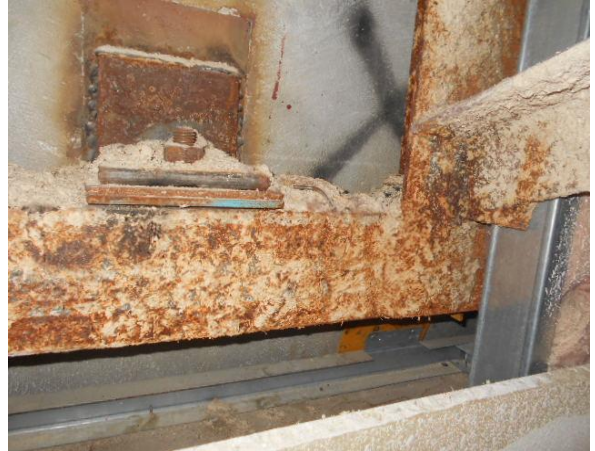
**Photo #34** Representative view above the drop-ceiling, where the precast panels tie into the steel bracing; typical surface rusting.

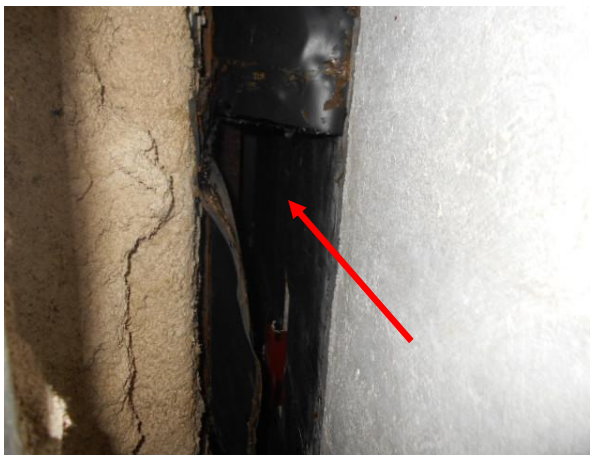
**Photo #35** Looking up into the parapet wall. The arrow denotes the open space.

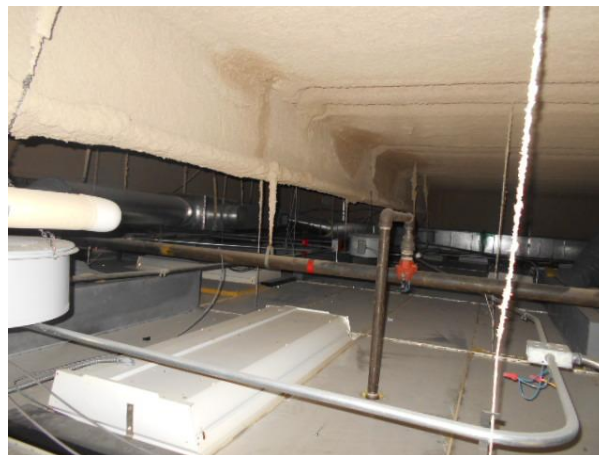
**Photo #36** Representative view above the drop ceiling. Typical water stains in the fireproofing are visible.

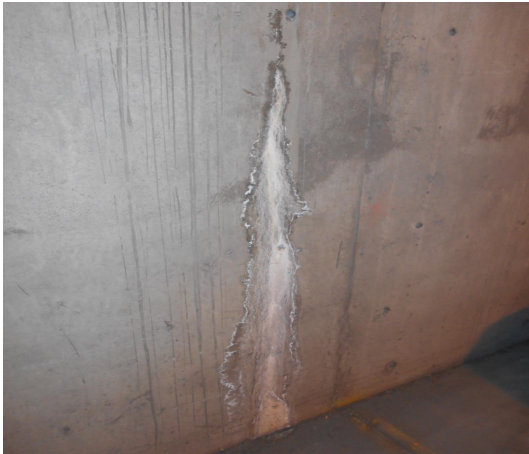
**Photo #37** Efflorescence through cracks in the parking garage walls.

The cracks in the underground parking garage are not indications of structural deficiencies, but appear to be more of an aesthetic issue. When the planter systems get removed and repaired, moisture infiltration into the garage should cease. The cracks then should be cleaned of accumulated mineral deposits and debris, and a concrete sealant should be applied. The sealant recommended is ICO Primer LV or LVFC, as manufactured by International Coatings of Frank Park, IL, or approved equivalent epoxy resin floor coating.

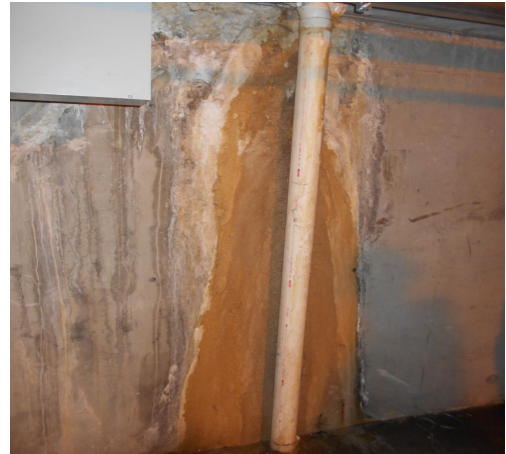
**Photo #38** Deposits from the leaking water in the parking garage forming around ceiling cracks.

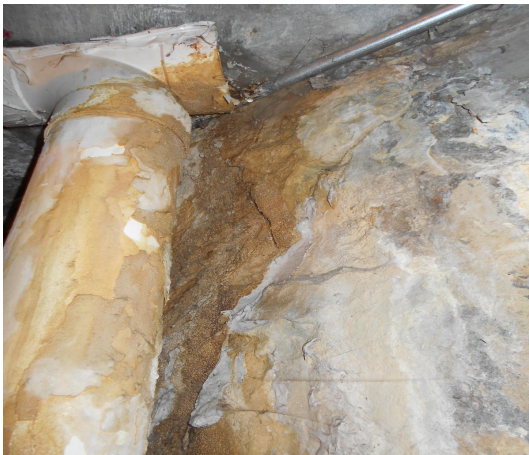
**Photo #39** Looking up at the concealed expansion joint in the parking garage ceiling by PVC pipe. The pipe is leaking.

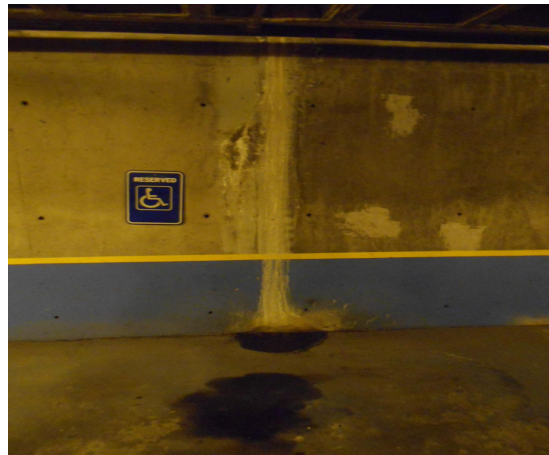
**Photo #40** Efflorescence as a result of the parking garage ceiling cracks.

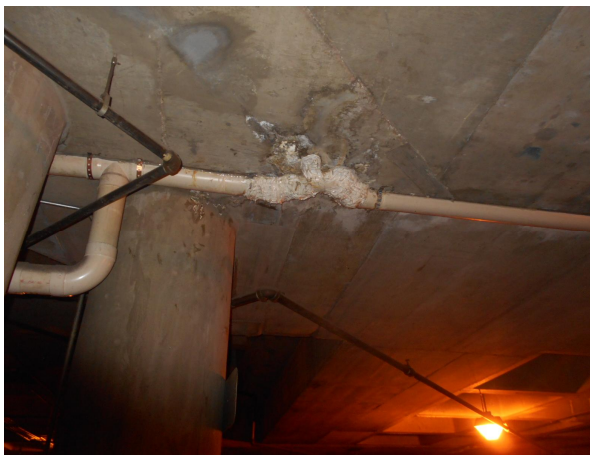
**Photo #41** PVC piping that conceals the expansion joint in the parking garage ceiling.

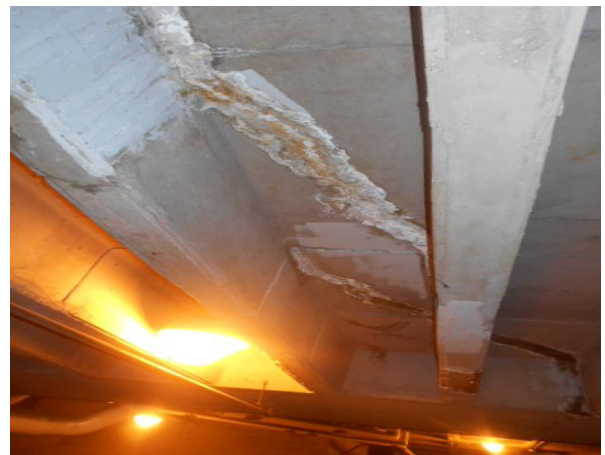
**Photo #42** Efflorescence in the parking garage ceiling cracks.

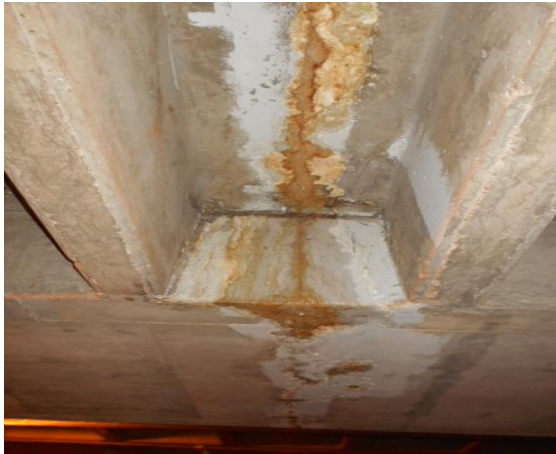
**Photo #43** Efflorescence in the parking garage ceiling cracks under planters.

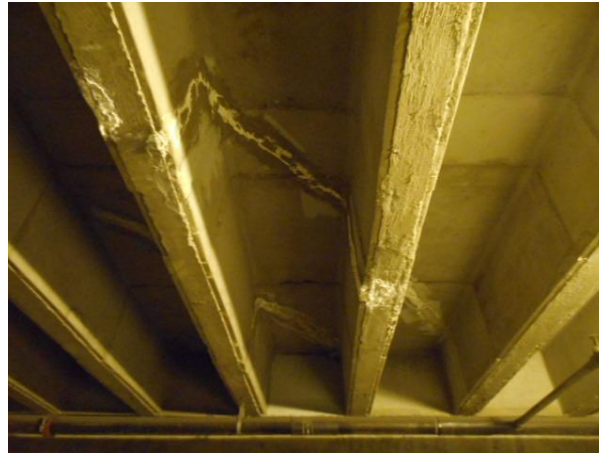
**Photo #44** Efflorescence in the parking garage ceiling cracks.

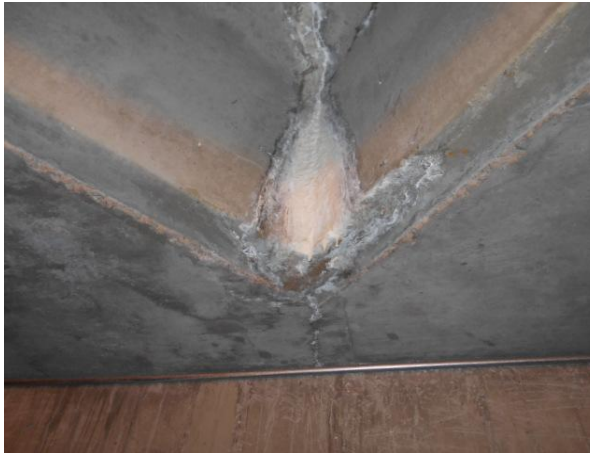
**Photo #45** Efflorescence in the parking garage ceiling cracks under planters.
